# Acoustic Camera

### A new modular design concept for acoustic arrays

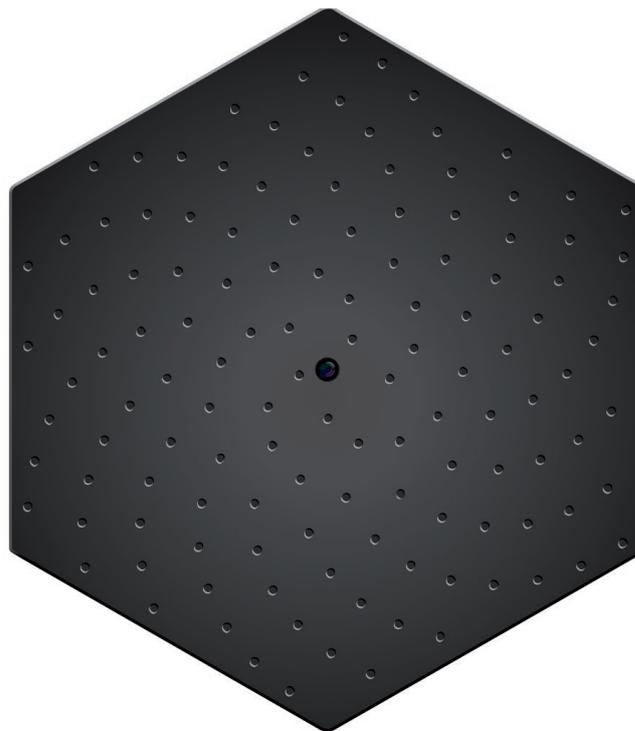
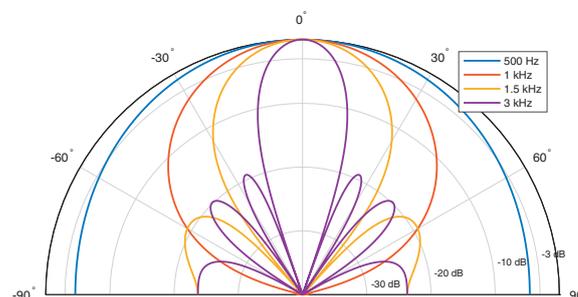
*Array geometry and beam pattern for Hextile*

With a single Hextile, the user has a small, portable and lightweight acoustic camera that can be used for a wide range of measurement situations. The Hextile is a USB based acoustic camera, with a single USB cable for both power and data transfer - no extra battery cable needed. The array is made from robust and lightweight aluminium, has 128 MEMS microphones, weighs 3 kg while having a maximum diameter of 46 cm. The low frequency limit for the Hextile is 410 Hz.

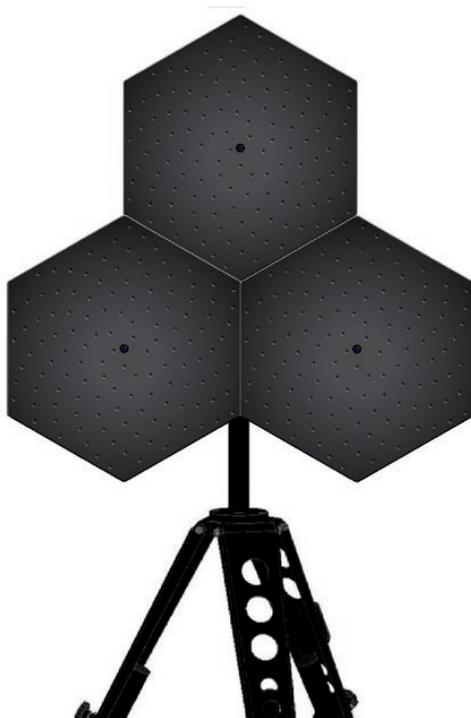
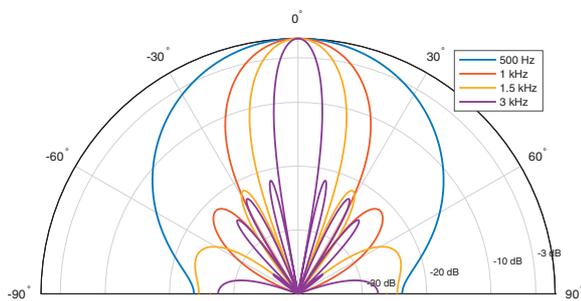
*Array geometry and beampattern for Multitile*

For users that require better resolution both in lower frequencies and overall, three single Hextiles can be combined to a larger Multitile system, consisting of 384 microphones with a maximum diameter of 96 cm. The low frequency limit for the Multitile is 220 Hz.

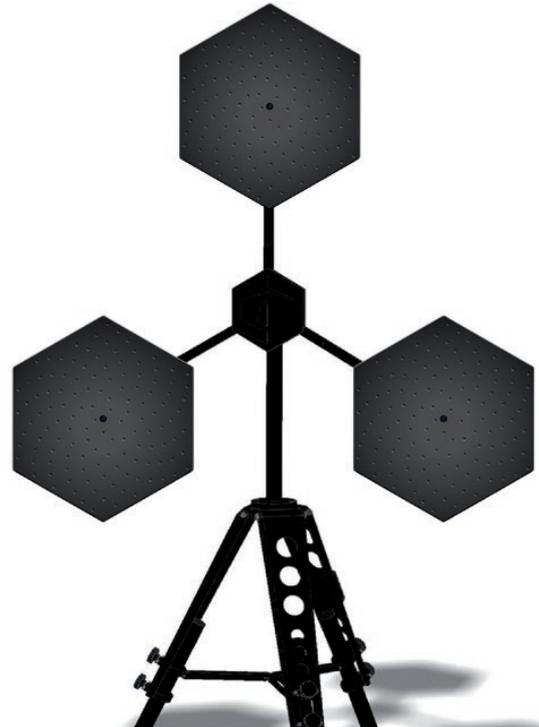
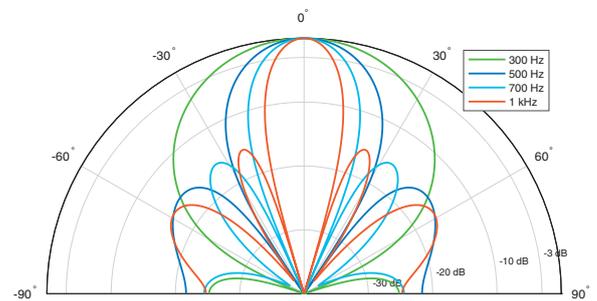
*Array geometry and beampattern for Multitile (LF mode)*

For special low frequency applications below 1 kHz, it is also possible to utilise the Multitile in the low frequency configuration. By placing the individual Hextiles further away, the maximum diameter of the complete array system is increased to 1.46 m, making it ideal for low frequency measurements. The Multitile in LF mode is for low frequency measurements below 1 kHz, with a lowest frequency limit of 120 Hz.

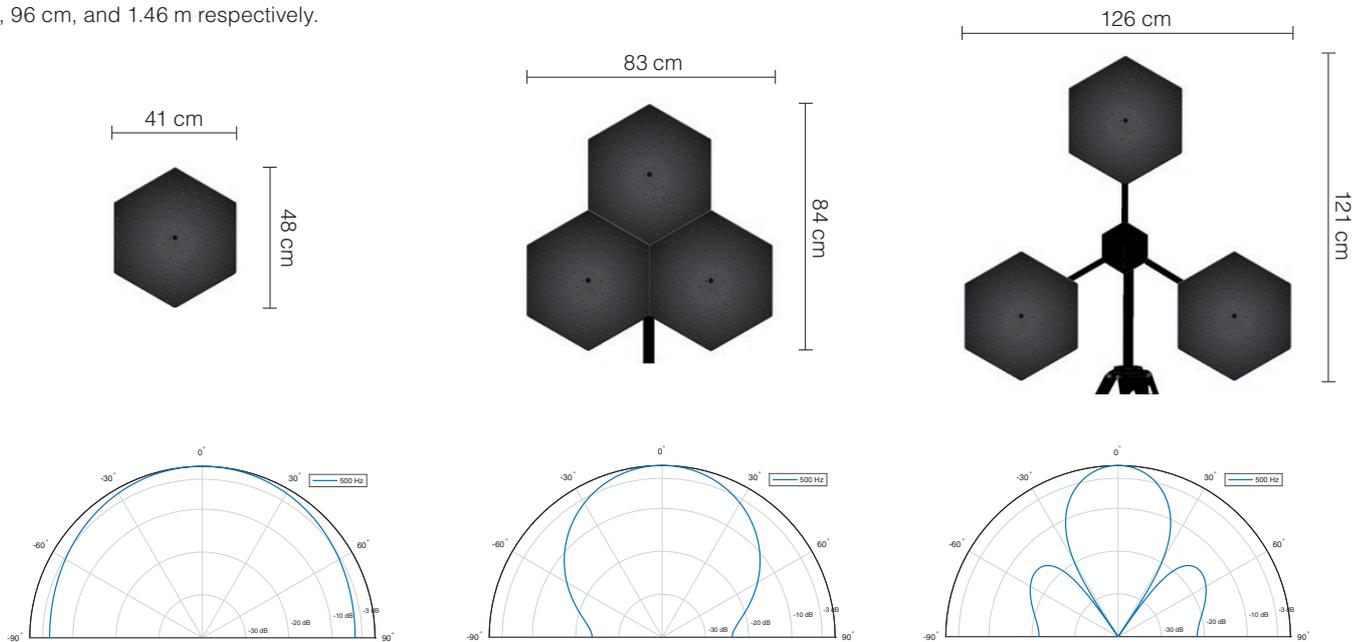
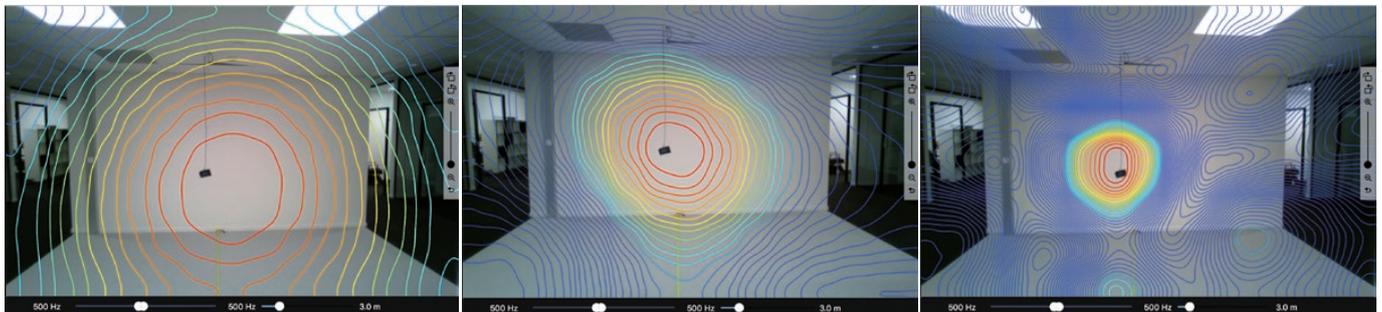
At the top are the different array configurations used for the recordings, with a 128 element Hextile, a 384 element Multitile, and a 384 element Multitile in LF mode. The diameters of the array configurations are 46 cm, 96 cm, and 1.46 m respectively.

The second rows show the beampattern for the different array configurations at 500 Hz and 3 dB dynamic range. As can be seen the beampattern gets more narrow, thus giving better resolution, as the overall array size increases.

Lastly the plotting results from the three different array configurations recorded on a real noise source are shown with 3 dB dynamic. The improvement in terms of resolution and pin-pointing the source is clearly visible when using bigger equipment.

Array geometry, beampattern at 500 Hz, and plotting results of pink noise source filtered at 500 Hz for Hextile, Multitile and Multitile (LF mode)

The biggest improvement when going from a single Hextile to the two different Multitile configurations is best demonstrated on a low frequency source. Seen below are the results from recordings on a single omnidirectional noise source emitting pink noise, with the colour plotting being done when the input signals are filtered at 500 Hz. This should give a direct comparison of the low frequency capability of the different arrays.

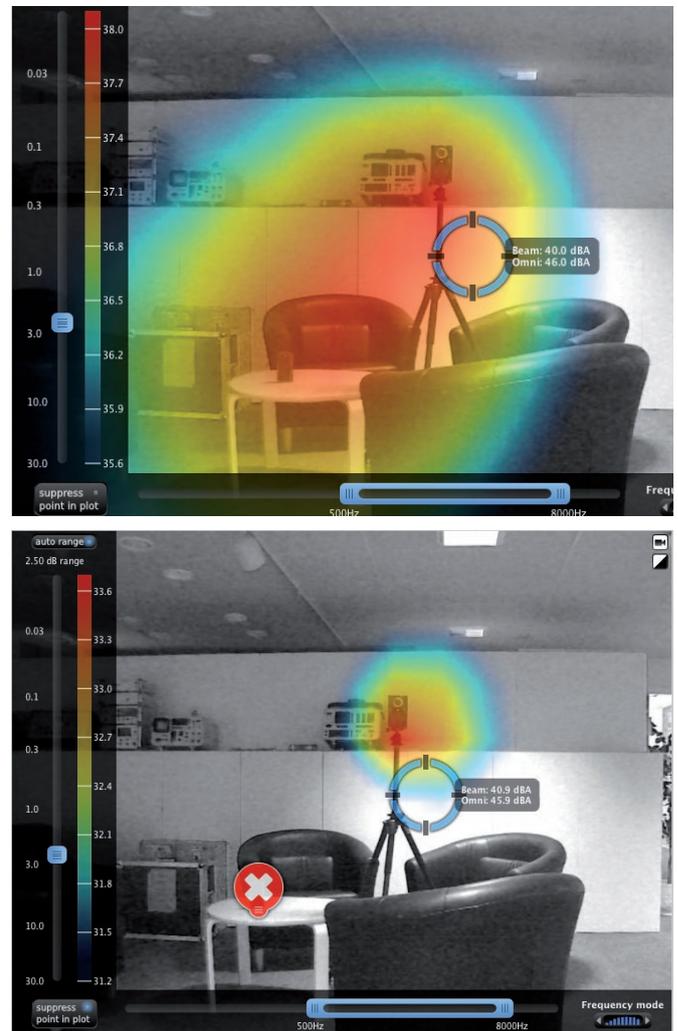
Sometimes sources may be closely spaced apart, or a strong noise source in the area of interest is interfering with the recording and impairing the image quality. Often this will be seen as either a single large source, or the source of interest will be completely shadowed by the stronger source. Seen in the image below is a situation where two equally strong sources are positioned close to one another, and

the resulting colour plot will display a single large source. In such situations the acoustic eraser feature may prove valuable. This function will add a red circle to the screen that can be dragged to any point, and remove the source from that point. This is highly effective when several noise sources are present. As seen on the pictures the acoustic eraser completely removes the source where the suppress point button is positioned. The virtual microphone can further be positioned on the source of interest.

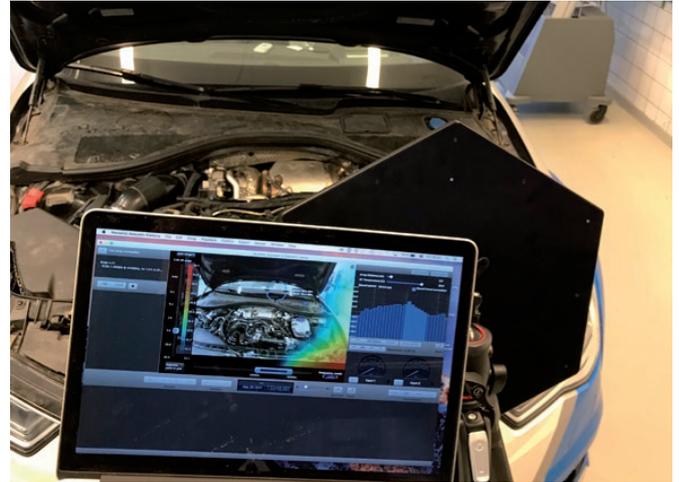
In the spectrogram window, frequency as a function of RPM is plotted. It is further possible to select a square in the spectrogram window to isolate interesting events. By pressing the “apply” button on the selection, the RPM and frequency limits in the main view window automatically change to the limits set by the selection in the spectrogram. The user may then find and interesting sound event in the spectrogram, and automatically get the corresponding colour plotting of the event chosen.

Virtual microphone position selected by the cursor. Used for analysis and listening

Especially in automotive applications RPM measurements may give vital information. The acoustic camera software has the possibility to display frequency content as a function of RPM by using the order analysis function.

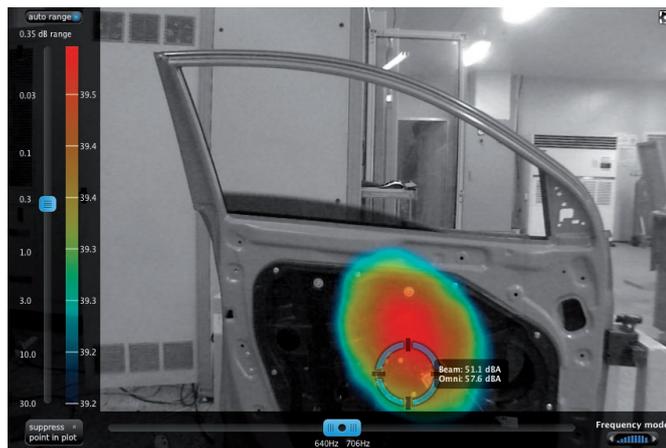
In addition to the high pitch squeak noise, sound from the electric engine could also be heard which was around 670 Hz. Since this sound was present during the entire recording, it could be easy to misinterpret the results and pinpoint the source of the high pitch noise to the wrong location without doing proper analysis. As seen in the image below, the location of the electric engine was in the middle of the door.

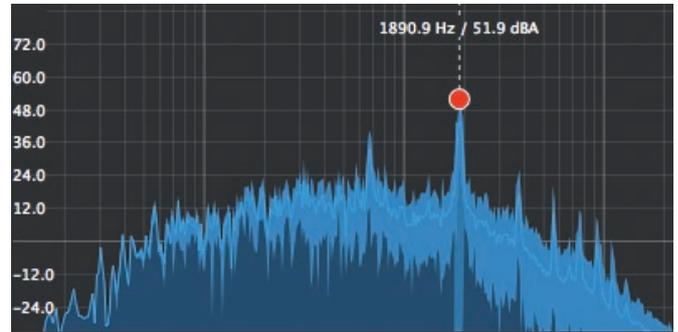
As opposed to the stationary sound from the electric engine, the high pitch squeak noise was only happening for a brief period of time, around 300 ms. By defining a scene in the sound level indicator

pane of the acoustic camera software, it was then possible to analyse events happening only within the time frame of the extent of the scene. The scene is made by simply dragging the cursor over the region of interest in the software.

Now by calculating the average spectral density over that part of the recording, it was easy to see that in addition to the noise from the electric motor around 670 Hz, a high pitch tonal noise with a fundamental frequency around 1890 Hz could also be seen in the frequency spectrum. In addition harmonics of the fundamental frequency up to the 7th harmonic was visible in the spectrum.

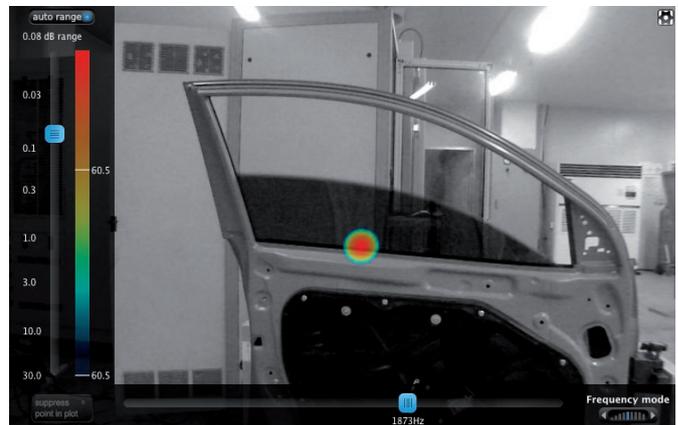
Now by filtering the frequency content of interest around the fundamental frequency, it was possible to get a clearer indication of the position of the source of the high pitch squeak noise as seen below. Due to the tonal nature of the noise it was possible to switch from the ordinary, robust wideband algorithm, to the adaptive algorithm for narrowband applications. This further helped in pinpointing the exact location of the problem. Higher resolution could also be achieved by zooming further in the image.

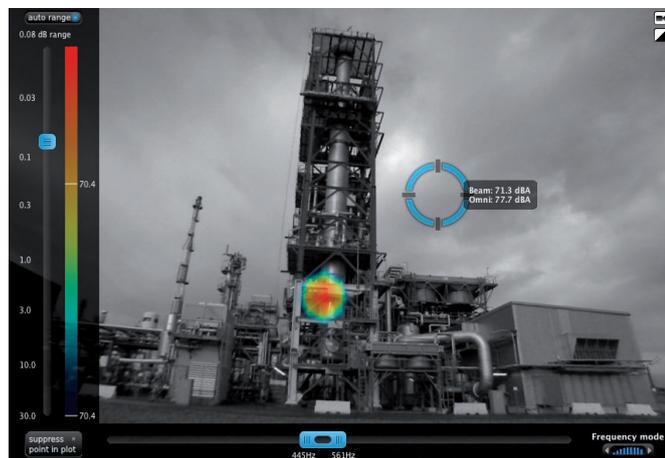
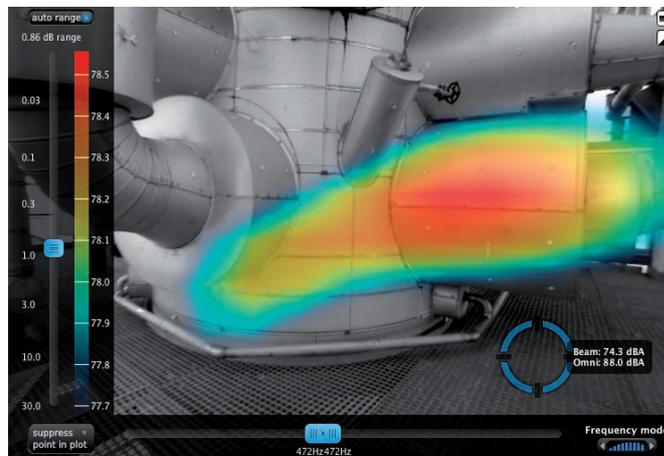
By positioning the center of the array towards the pipe and adjusting the frequency to display only coloring within the 500 Hz 1/3-band, the noise source was located within seconds, and the source producing the tonal part from the pipe was detected. Measurements from different measurement positions also confirmed the source location. By placing the virtual microphone on the localised source and using the spectrogram function, it was easy to verify the position of the source emitting a tone at 460 Hz.

Although the measurement location had quite windy conditions, the wind noise did not affect the measurement results at all. Wind noise can be viewed as spatially white, which means that wind noise sampled at different places in space, is not correlated from position to position. When many different signals from many microphones are added in the beamforming algorithm, the wind noise will be added out of phase and attenuated proportional with the number of microphones being used.

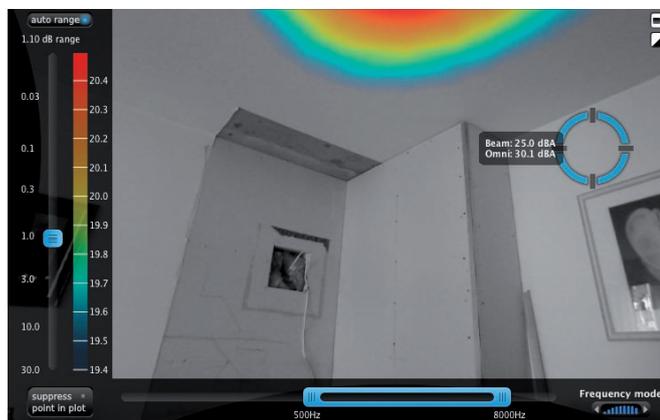
When filming at the location of the encased pipes in the corner of the living room, the acoustic camera did not pick up any energy at that position, but rather the colouring was upwards towards the roof and outside the field of view of the camera at that measurement position.

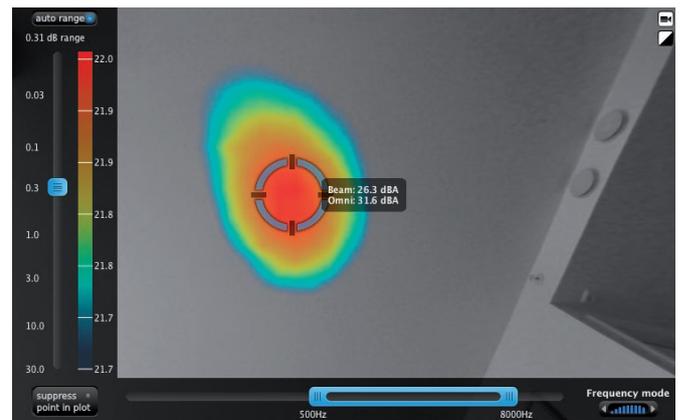
By using the virtual microphone, which enables the user to listen to a specific position in both real time and in a recording, one could clearly hear the sanitary noise from the recorded position at the roof. Also by enabling the bandpass filter one could further be able to filter out background noise and very clearly hear the sanitary noise from the piping. Based on these measurements one could deduce that the water pipes in were in fact not positioned as previously thought.

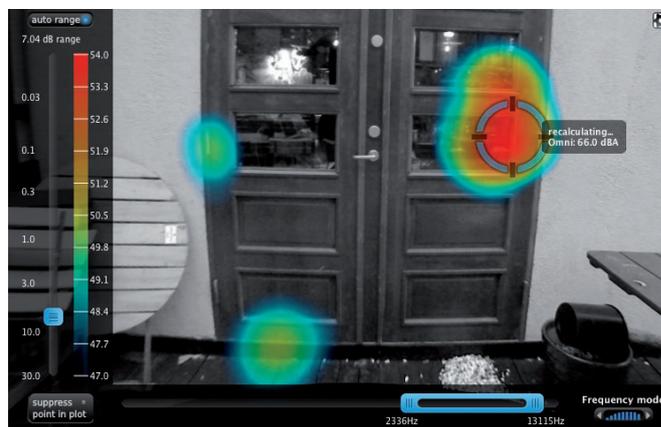
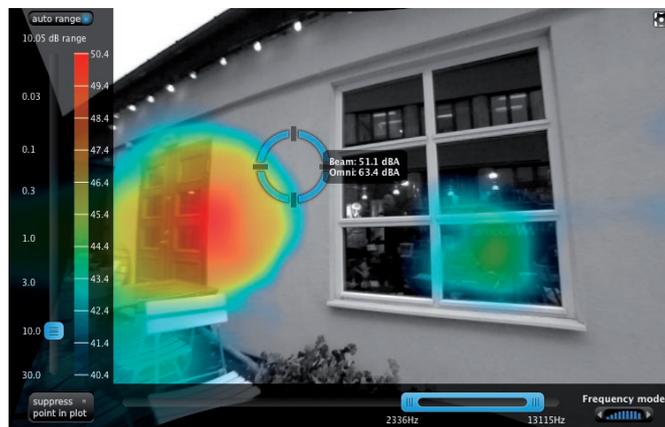
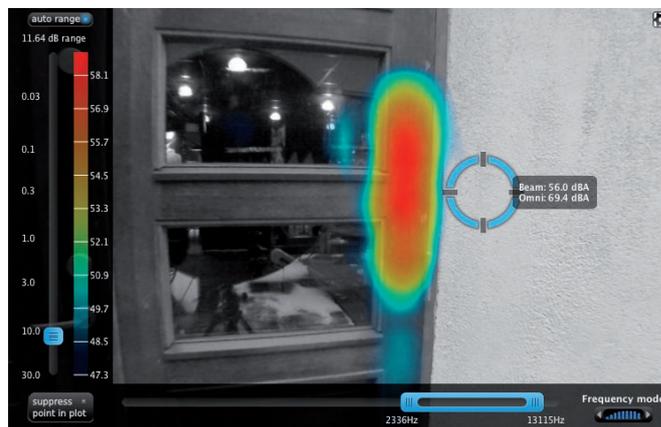
The wall between the café leading to the patio consists of both a door and several windows. The first step consisted in seeing what made the biggest noise contribution. As seen in the image below, where the dynamic range is set to 10 dB, the door had a noise contribution that was approximately 10 dB higher than the nearest window.

By focusing on the door only it was further possible to locate the exact position of, and zoom in on, those weaknesses as seen in the images below.

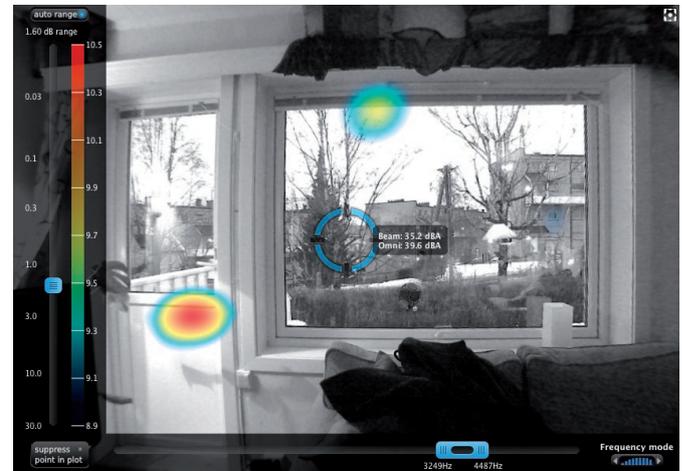
Initial recordings when using traffic as noise source displayed a single strongest facade weakness at the top left of the living room wall. This strongest source position was also confirmed when using the omnidirectional loudspeaker as noise source. At this position a ventilation valve was installed, and most of the traffic noise came from this location.

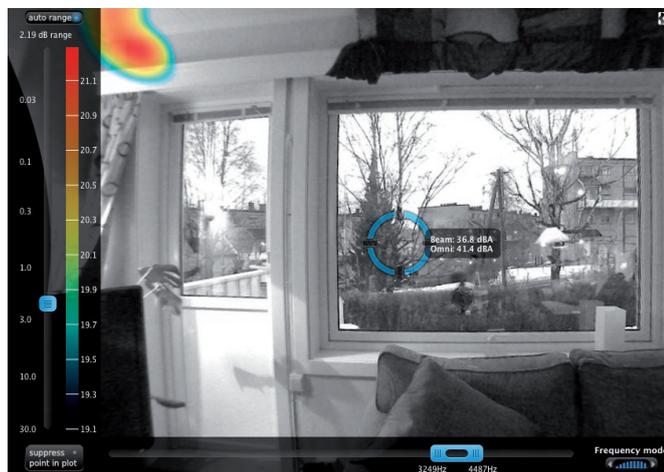
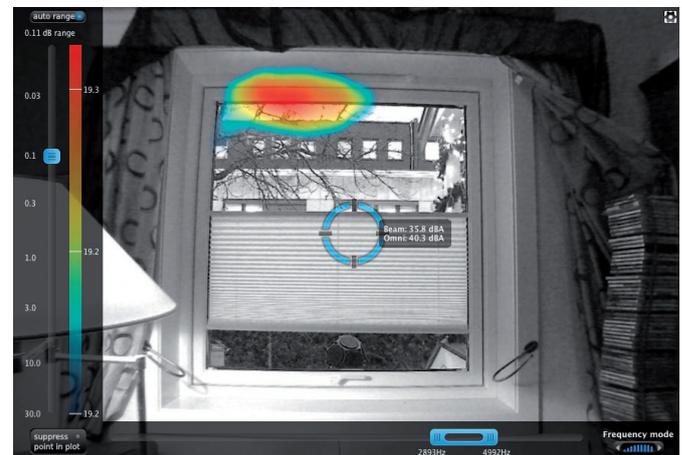
Having determined that the intake valve was the main noise contributor, this spot was covered up with a pillow to remove it from the overall noise field, and try to locate secondary sources. By filtering on a relatively high frequency band around 3 - 4 kHz, it was possible to filter out only the noise being emitted by small gaps and cracks. This produced two new possible weaknesses, one on the porch door, and another on the air valve above the window.

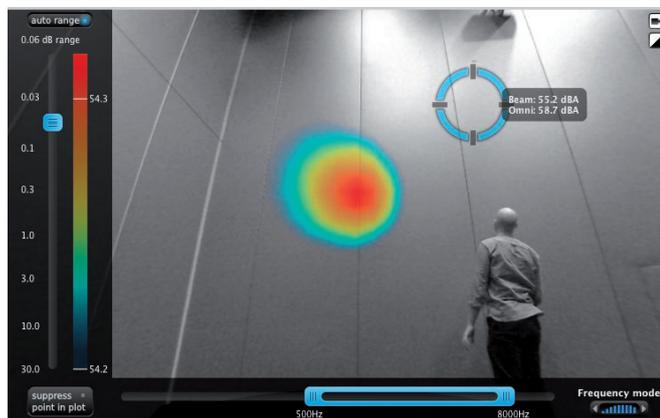
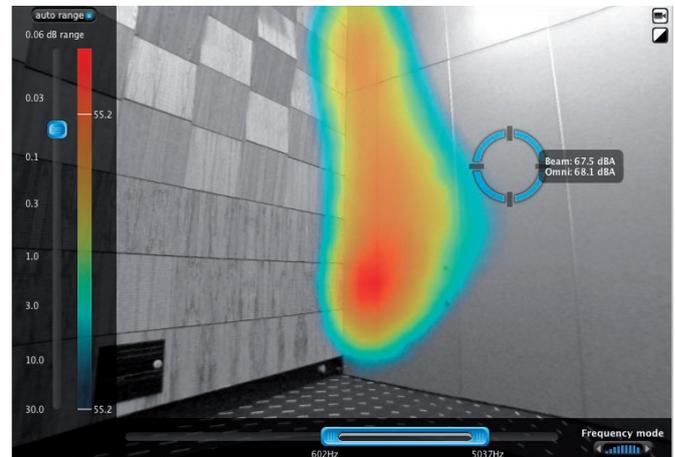
Due to the large size of the modular walls, the camera was pointed to different areas of the walls, and several measurements were made. The individual measurements could then be examined further in post-processing analysis. Due to the source being used at high volume in the sending room, cracks and gaps in the modular walls would appear as small noise sources at specific location on the walls when recording with the acoustic camera in the receiving room. The acoustic camera was able to locate several weak spots on the walls, even though the range where differences could be discovered were for certain areas below 0.05 dB.
